BOURNE PE10 0AU - STORAGE DEPOT

Project	JJM2505 - Storage Depot
Location	Bourne
Client	HZ Logistics
Key works delivered	Ground Stabilisation
Project Duration	Sept 2020 - 1 WEEKS
Stabilised Area	2,000m ²
Earthworks volume

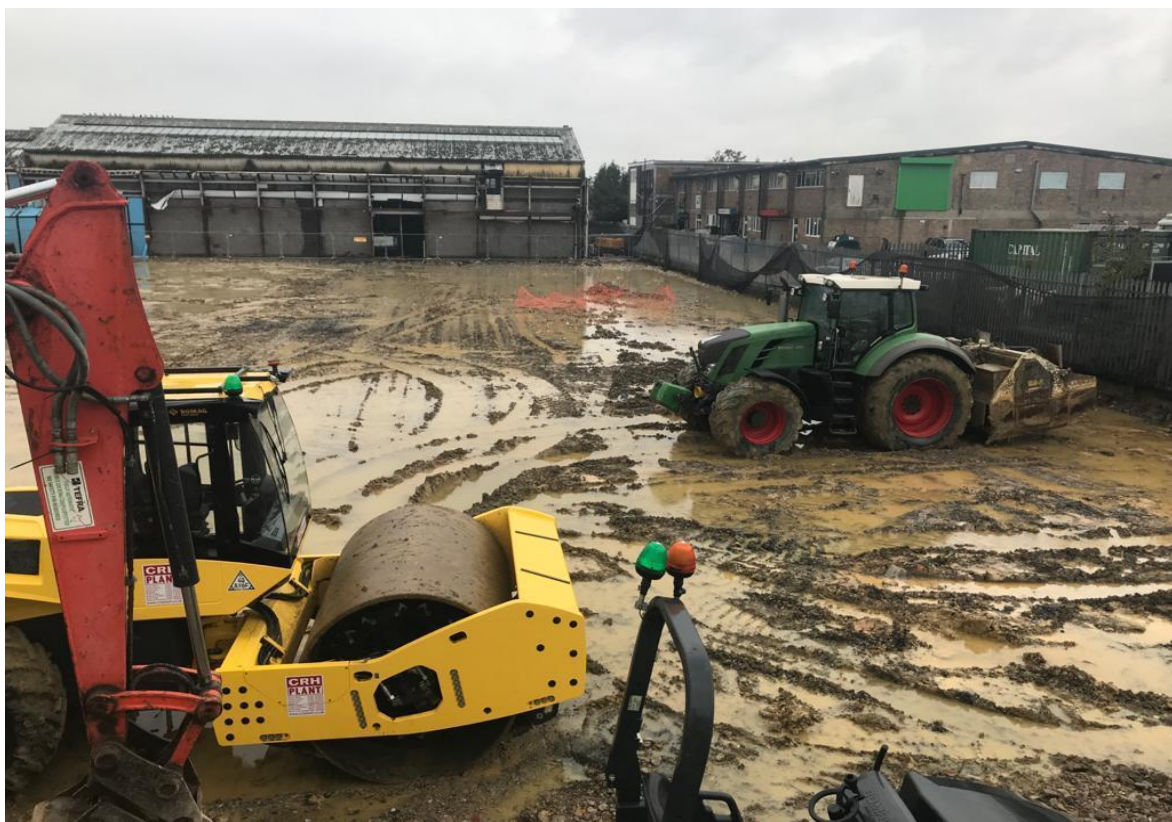
New works to the storage yard and surrounding building – Weather turned and works halted. Options considered by the client.

- Worked with the client and advised on the finding of the existing **Site Investigation Information** as to the best and quickest solution for a stabilised site.
- We carried out on site **CBR testing** to enable our Designers to generate a very efficient design solution for our client
- Our site team then set to work to improve the soil and dry out the site with lime and then created a 300mm thick layer of stabilised soil using cement

- The works had a two-fold advantage to this site. **JJMac Ground Stabilisation Dried** the site out, saving programme time. The 300mm cement layer (once capped with Type1) served as a **Piling and Working Platform** to allow the site works to continue in dry clean conditions
